Manhole Inspection Summary

Manhole # S39KK_020MH

Insp Date: **2/28/07 10:31 AM**

Location Address: **1201 NORTH AVE**

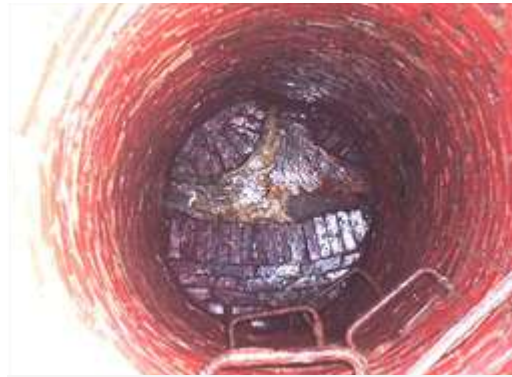
Top View

Corroded steps. Channel debris.

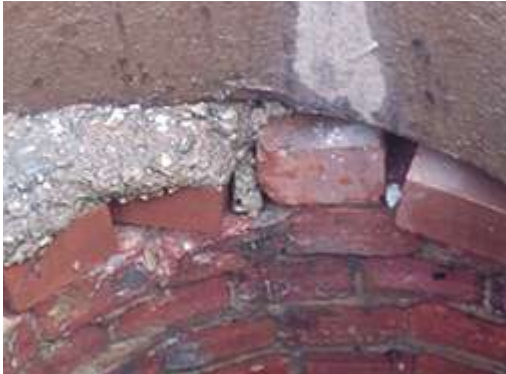
Defect

Frame leaks. Frame leaks. Adjustment deterioration, loose brick and infiltration.

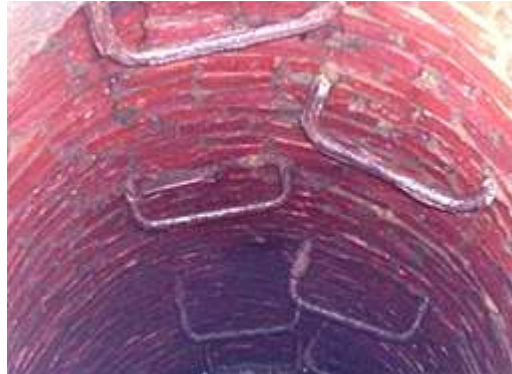
Defect

Adjustment, Corbel and Barrel infiltration.

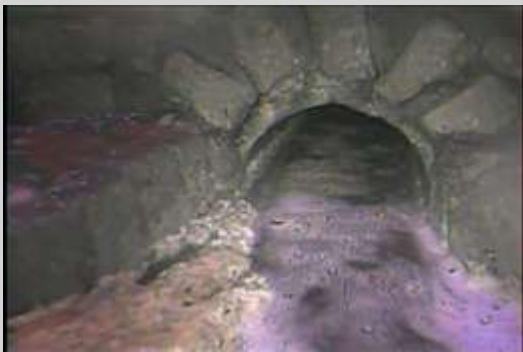
8 in. Circular Gravity Sewer Pipe Out @ 12 O'Clock

Deposits: ☐ None ☐ **Mud** ☐ Sludge ☐ Debris ☒ **Grease**

Silt Depth: **0** (in.) Deposits Extent: **Medium**

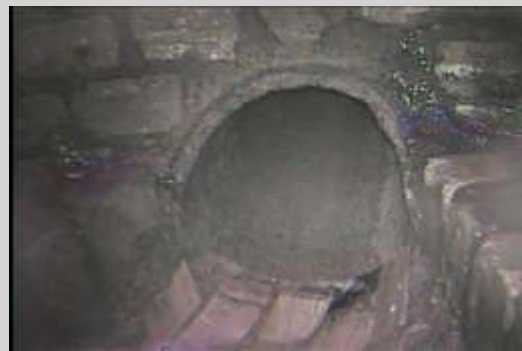
Drop In @ 3 O'Clock

Drop: **Outside** Rod and Bar

Drop Condition: **Open**

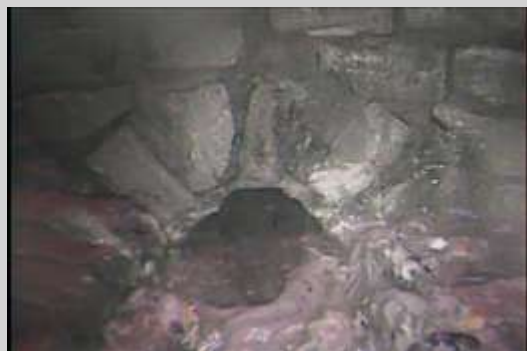
Pipe In @ 9 O'Clock

Deposits: ☐ None ☒ **Mud** ☐ Sludge ☐ Debris ☒ **Grease**

Silt Depth: **4** (in.)

Deposits Extent: **Heavy**

Pipe Seal Cond: **Broken**
